Samsung Recall Support Note7 Investigation

Root Cause Analysis

Kevin White, PhD Principal Scientist 23 January 2017

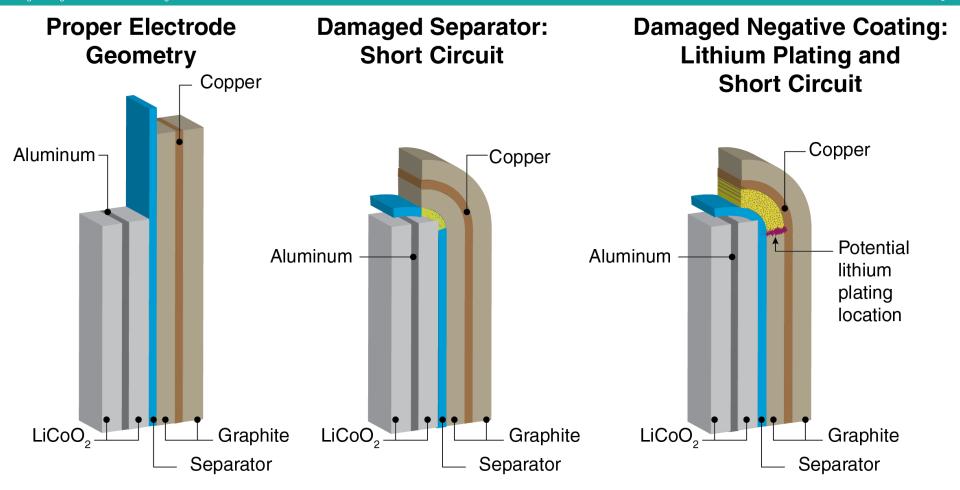
Root Cause: Manufacturer A

- Based on the results of analysis and testing, the most likely root cause for the thermal failure of certain Manufacturer A cells was determined to be unintended damage to the negative electrode windings consistently in the corner of the cell closest to the negative tab

- The unintended damage was present in all of the cells examined by Samsung and Exponent
 - The damage was caused by a cell pouch design that provided inadequate volume to accommodate the electrode assembly

- The observed damage provides multiple potential routes to internal cell faulting and thermal failure with normal cycling, including compromise of the separator and lithium plating

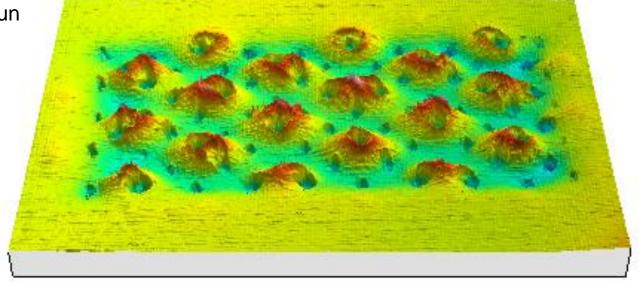
Root Cause: Manufacturer B

- Based on the results of analysis and testing, the most likely root cause for the thermal failure of Manufacturer B cells was determined to be internal cell faulting between positive electrode tab welding defects and the copper foil of the negative electrode directly opposite the defective welds
 - Welding defects in some incident cells were found to be tall enough to bridge the distance to the negative electrode foil
 - Some cells examined were assembled without protective tape over the positive electrode tab, increasing the likelihood of an internal cell fault

Poorly controlled welding of the positive tab in Manufacturer B cells creates sharp, relatively tall welding defect features

Normal swelling and contraction of the electrodes during charge and discharge forces the weld defect features into the opposing negative electrode

Short circuit between the weld defect feature on the positive tab and the copper of the negative electrode results in heating of the cell

At high states of charge, the cell heating results in thermal run away.
