Samsung Recall Support Note7 Investigation

Root Cause Analysis

Kevin White, PhD Principal Scientist 23 January 2017

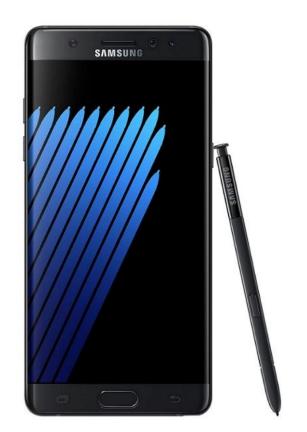
- After reports of failures in the field, Exponent was retained as an independent third-party to investigate the root cause for thermal failures of Note7 lithium-ion battery cells
- A suite of destructive and non-destructive techniques was used to evaluate the field failure and exemplar cells from both manufacturers that provided cells to Samsung
- In addition to analysis of the cells, an analysis of the design of the battery, device and electronics was conducted
